Subject: 2014 Inspection Cycle.

**L41611000+02001**

Location : 7M SE HAMILTON Structure Name: none

SLEEPING CHILD CREEK ON LITTLE SLEEPING CHILD ROAD  
CHANNEL BOTTOM PROFILE AT THE SOUTH FOOTING.

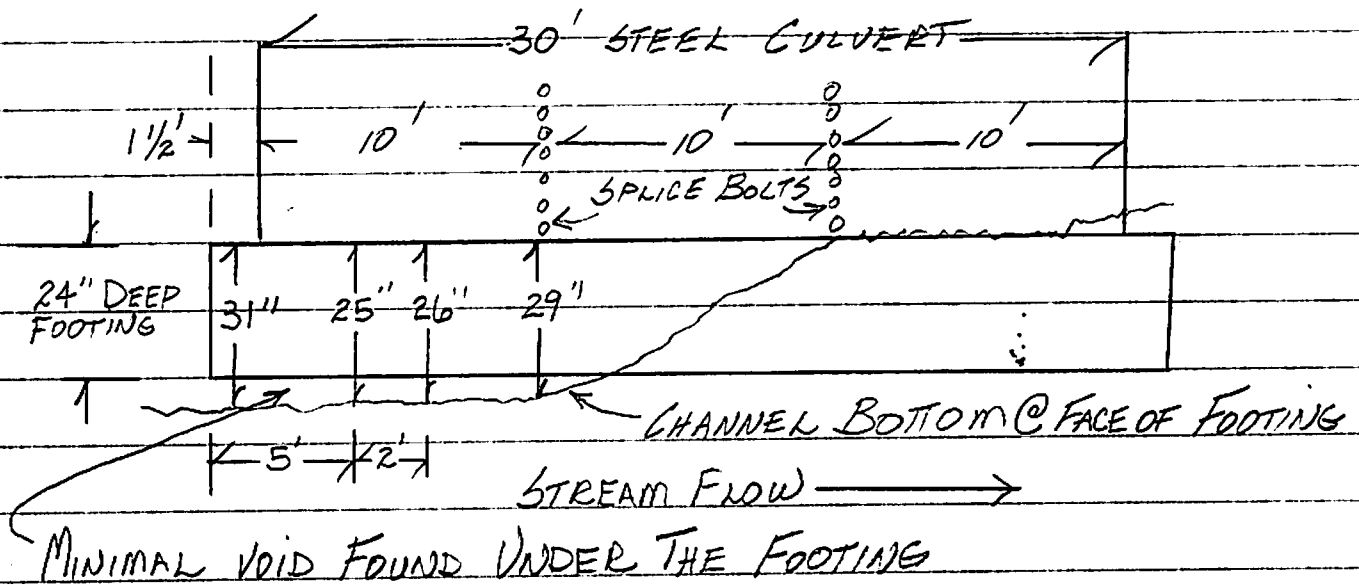
LOOKING AOL & SOUTH

L41611000+02001 Sleeping Child Creek  
Recommended Maintenance: Take appropriate measures to prevent undercutting of the footings and upstream wingwall at the south footing.

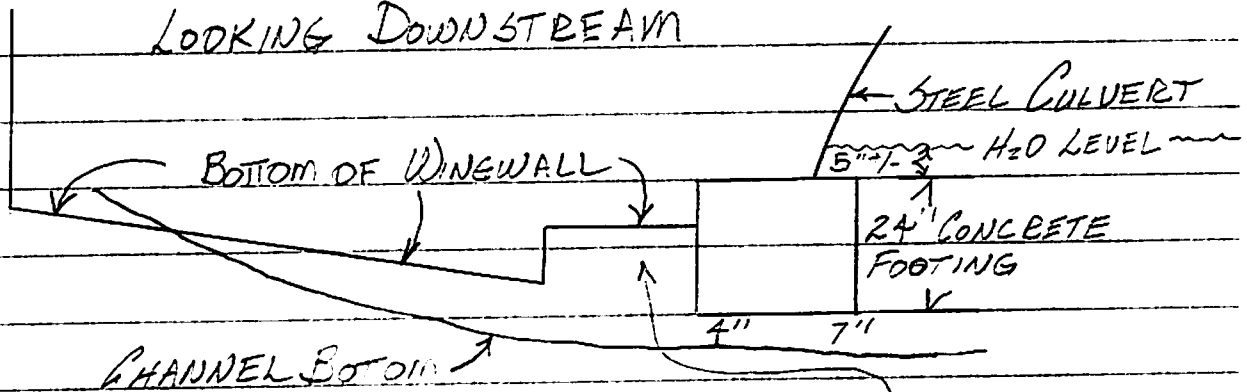
CHANNEL BOTTOM PROFILE AT THE UPSTREAM  
WINGWALL OF THE SOUTH FOOTING.

LOOKING DOWNSTREAM

THE VOID UNDER THE WINGWALL AT FILL SIDE OF THE  
FOOTING MEASURED 1 1/2' FROM THE STREAM FACE  
OF THE WINGWALL

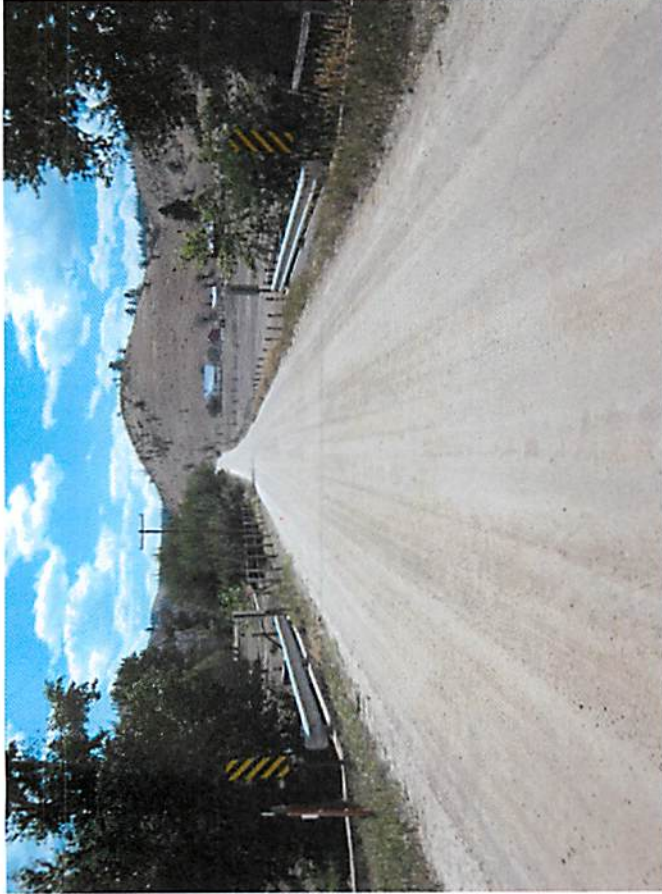
**AOL**

Looking south. Stream flow is from left to right.

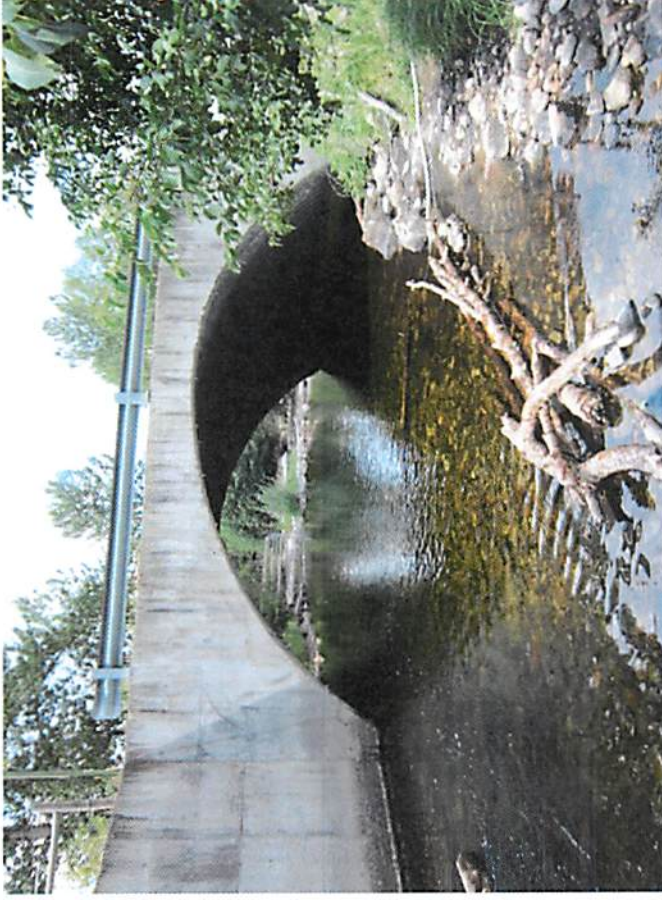
**Left side**

Looking downstream.

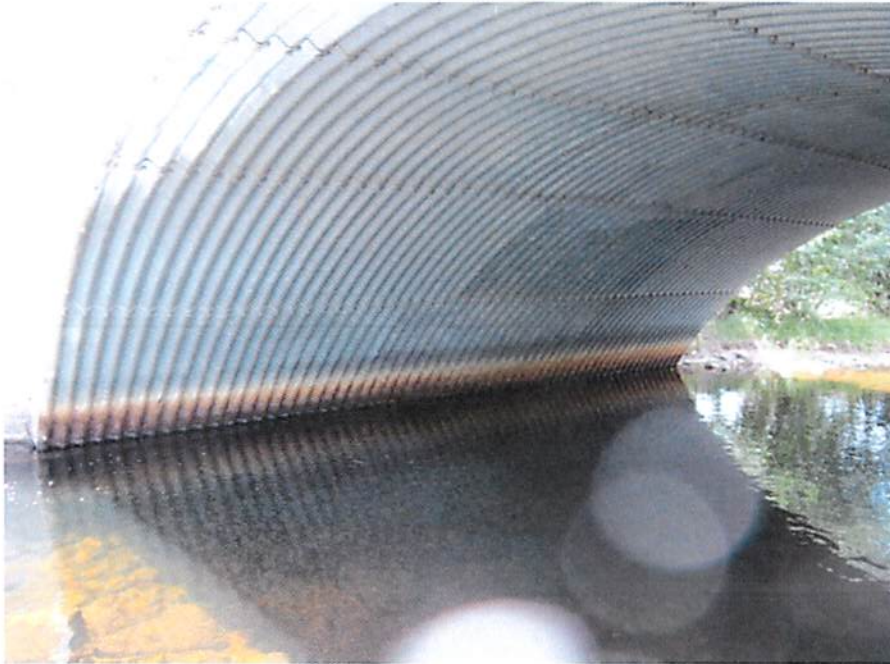
Typical staining  
Notes

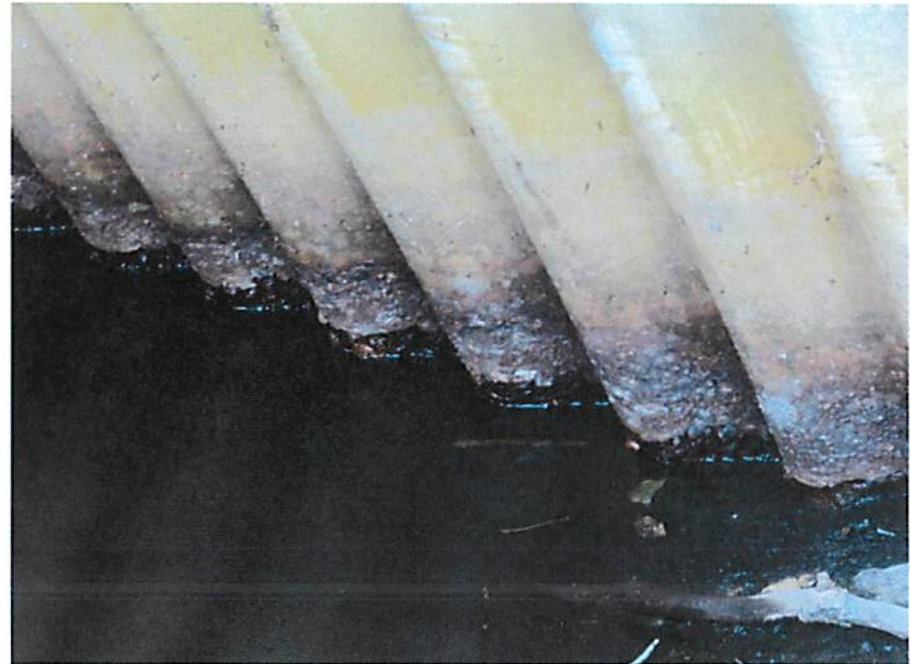
Typical rust  
Notes

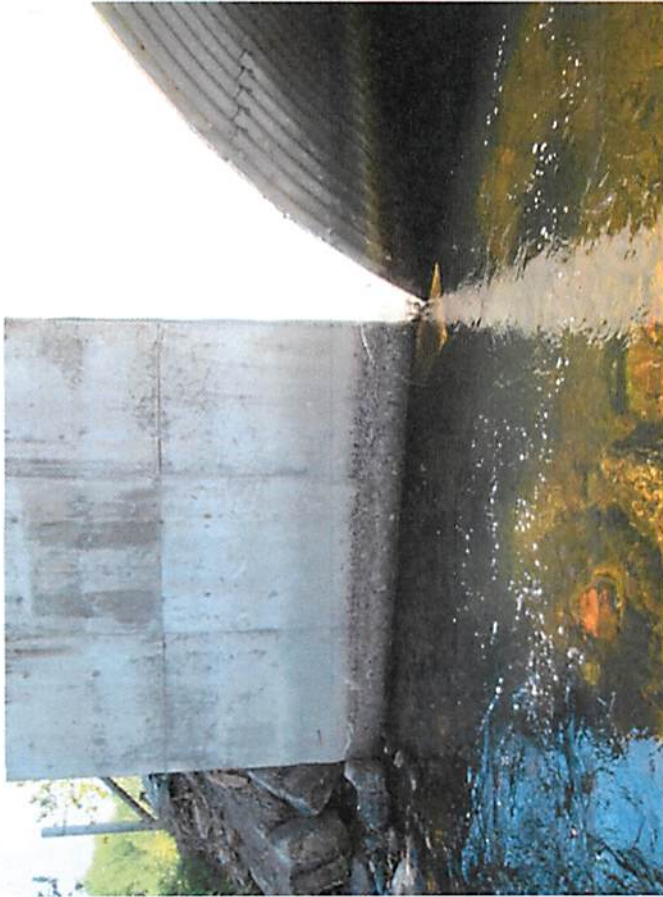
7/31/2014 photo

South abutment wingwall and end of footing on the upstream end.

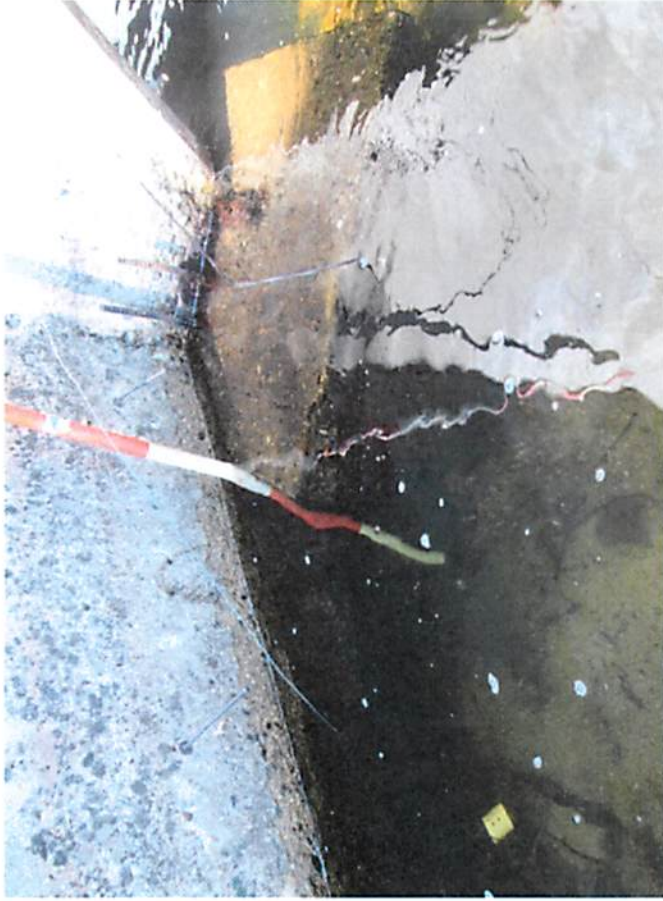
7/31/2014 photo

Looking downstream at the upstream end of the south abutment footing and wingwall.

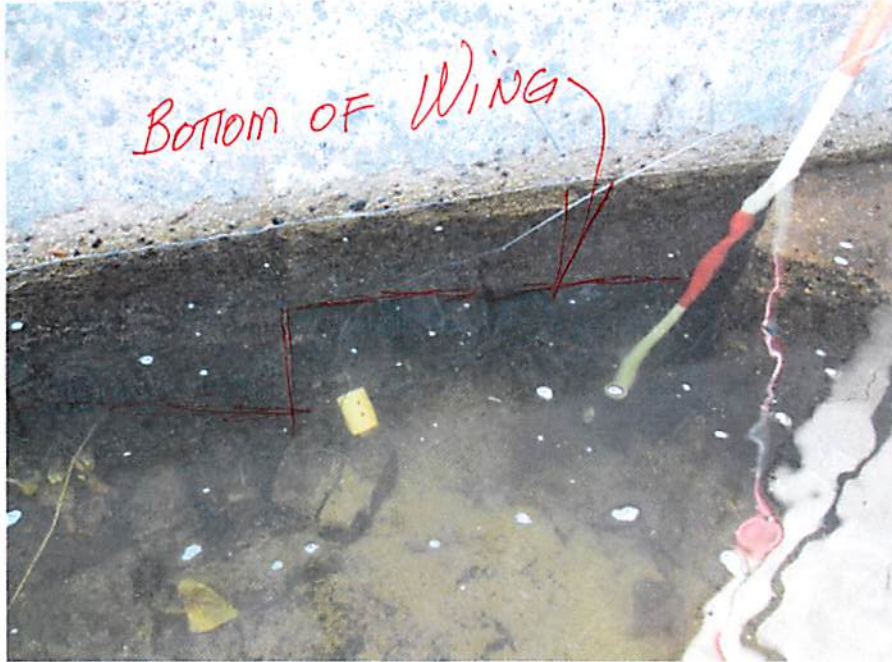
7/31/2014 photo

Same as the previous photo. In this photo, you can see the notch in the bottom of the wingwall at the footing. There is a small void under this notch along the fill face of the footing for approximately 1 1/2 feet. The bottom of the wing is exposed for most of its length.

Inspection Work Candidates		Status	Priority	Effected Structure Unit	Scope of Work	Action	Covered Condition States
Candidate ID	Date Requested						
D11-FY2014-000064	13 August 2014	Not Approved	Medium	M Main	Bridge	Scour	
Take appropriate measures to prevent undercutting of the footings and upstream wingwall at the south footing. See General Inspection Notes, photos and attached sketch.

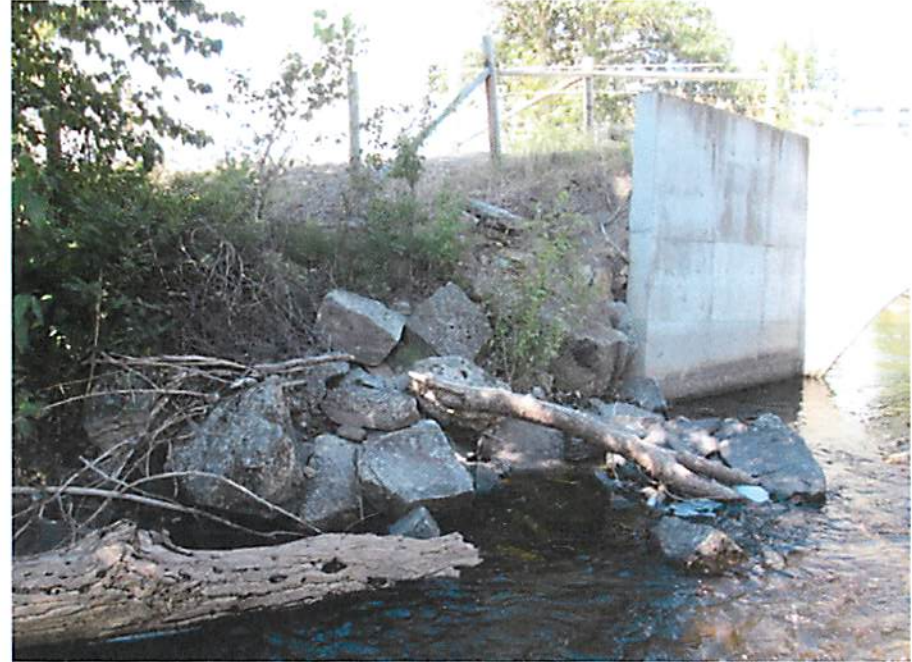
7/31/2014 photo

Looking downstream along the south bank.
