Subject: 2015 Inspection Cycle.

L41338001+01001 Sweeney Creek

INITIAL ASSESSMENT FORM FOR STRUCTURE :

L41338001+01001

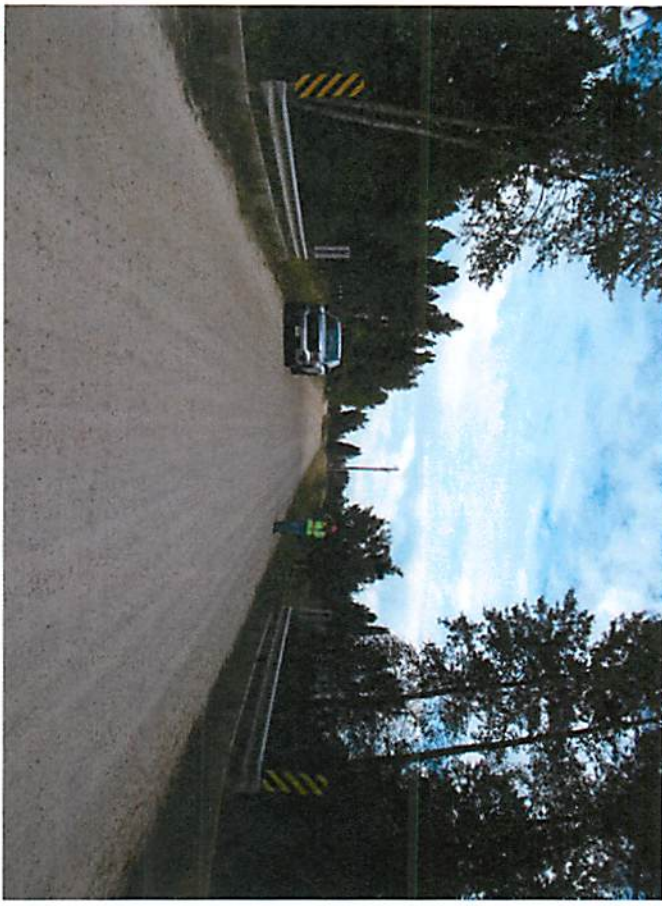
AOL

Looking north.

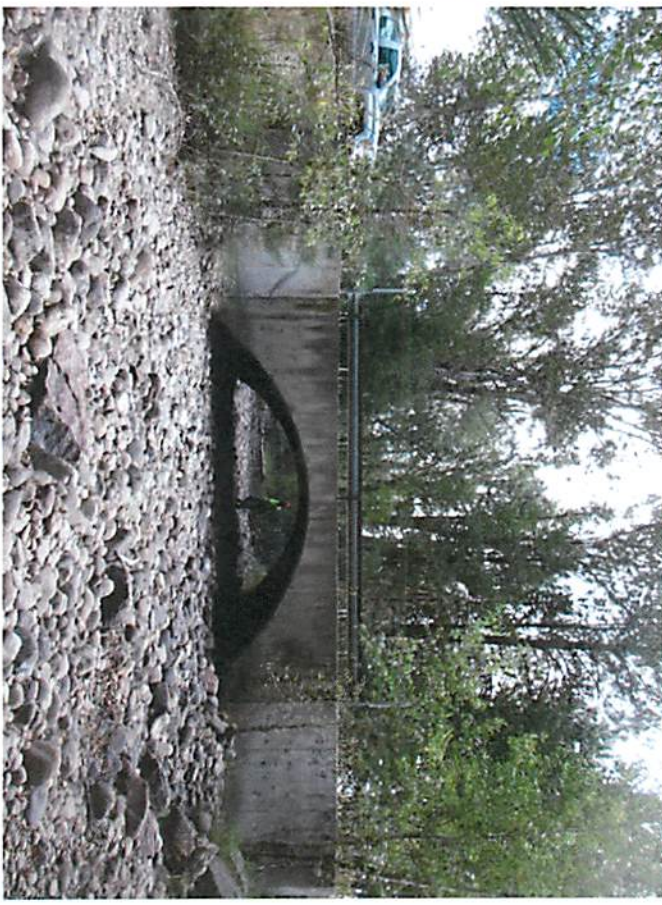
Profile Left

Looking downstream.

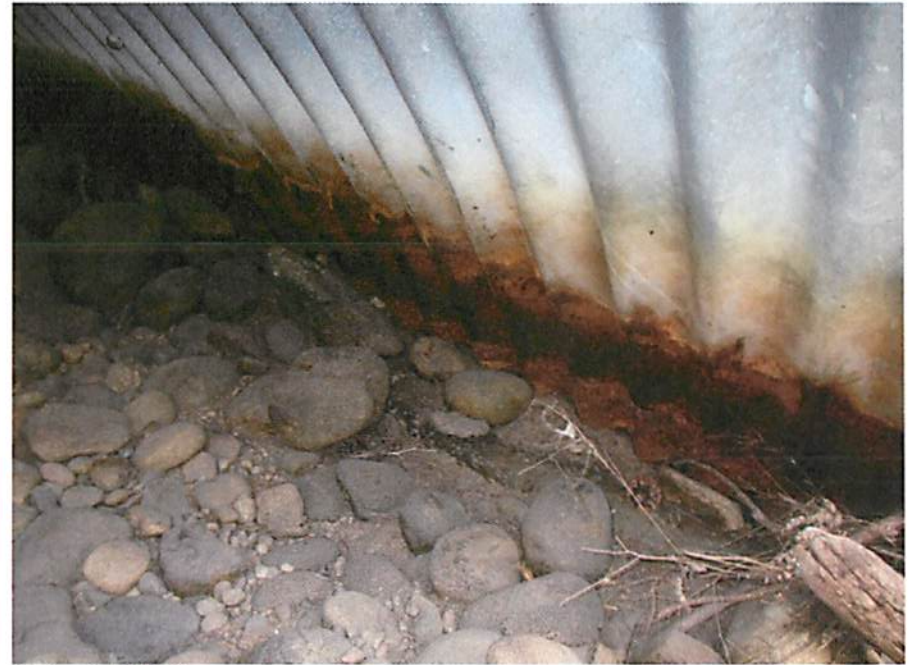
Culvert B1 Left
Notes

09/09/2015 - There is rust and corrosion with pitting of the culvert from the footings to approximately 18 inches up the arch. See photo. There was no distortion observed. JZMZ

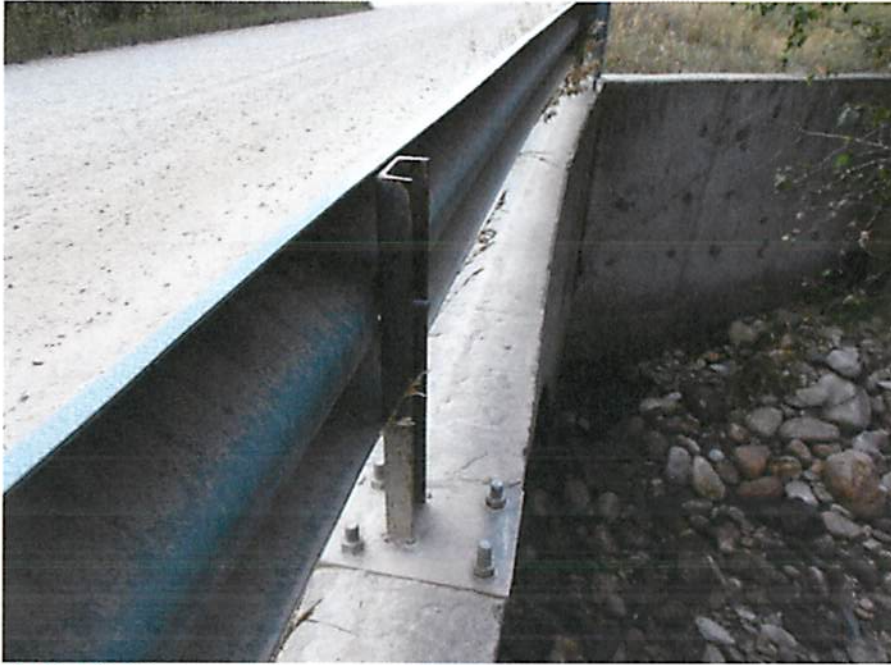
Rail Left BOL

09/09/2015 - There is speckled rust on the posts for the rails on both sides of the roadway. See photo. The posts are small channels. JZMZ
