An Examination of Home Destruction

Roaring Lion Fire Bitterroot Mountains, Montana

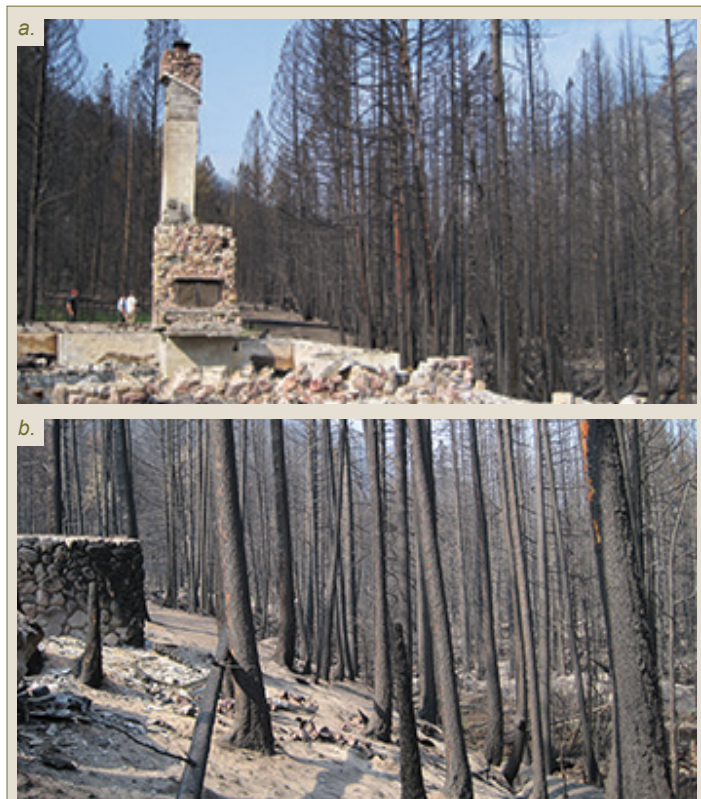
Figure 2. ACTIVE CROWN FIRE. These two separate but associated houses, a) and b) were several hundred feet apart. Both of these structures were 30 feet or closer to active crown fire.

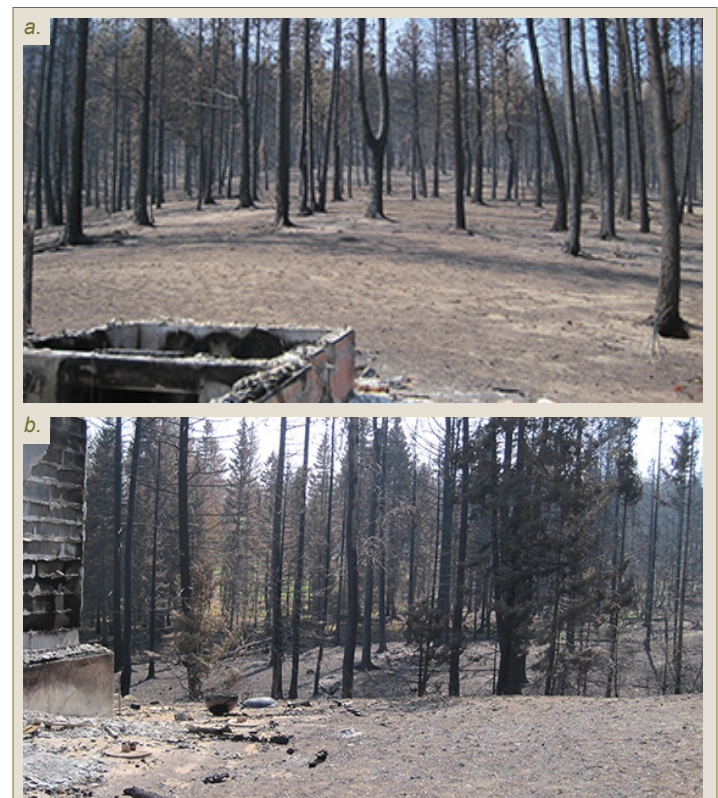
Figure 3. PASSIVE CROWN FIRE. Photos a) and b) are two different views from the same house. The incomplete canopy consumption indicates individual tree torching with brief passive crown fire in the background. The house was more than 60 feet from high intensity burning but note the complete consumption of continuous surface fuels leading to the house.

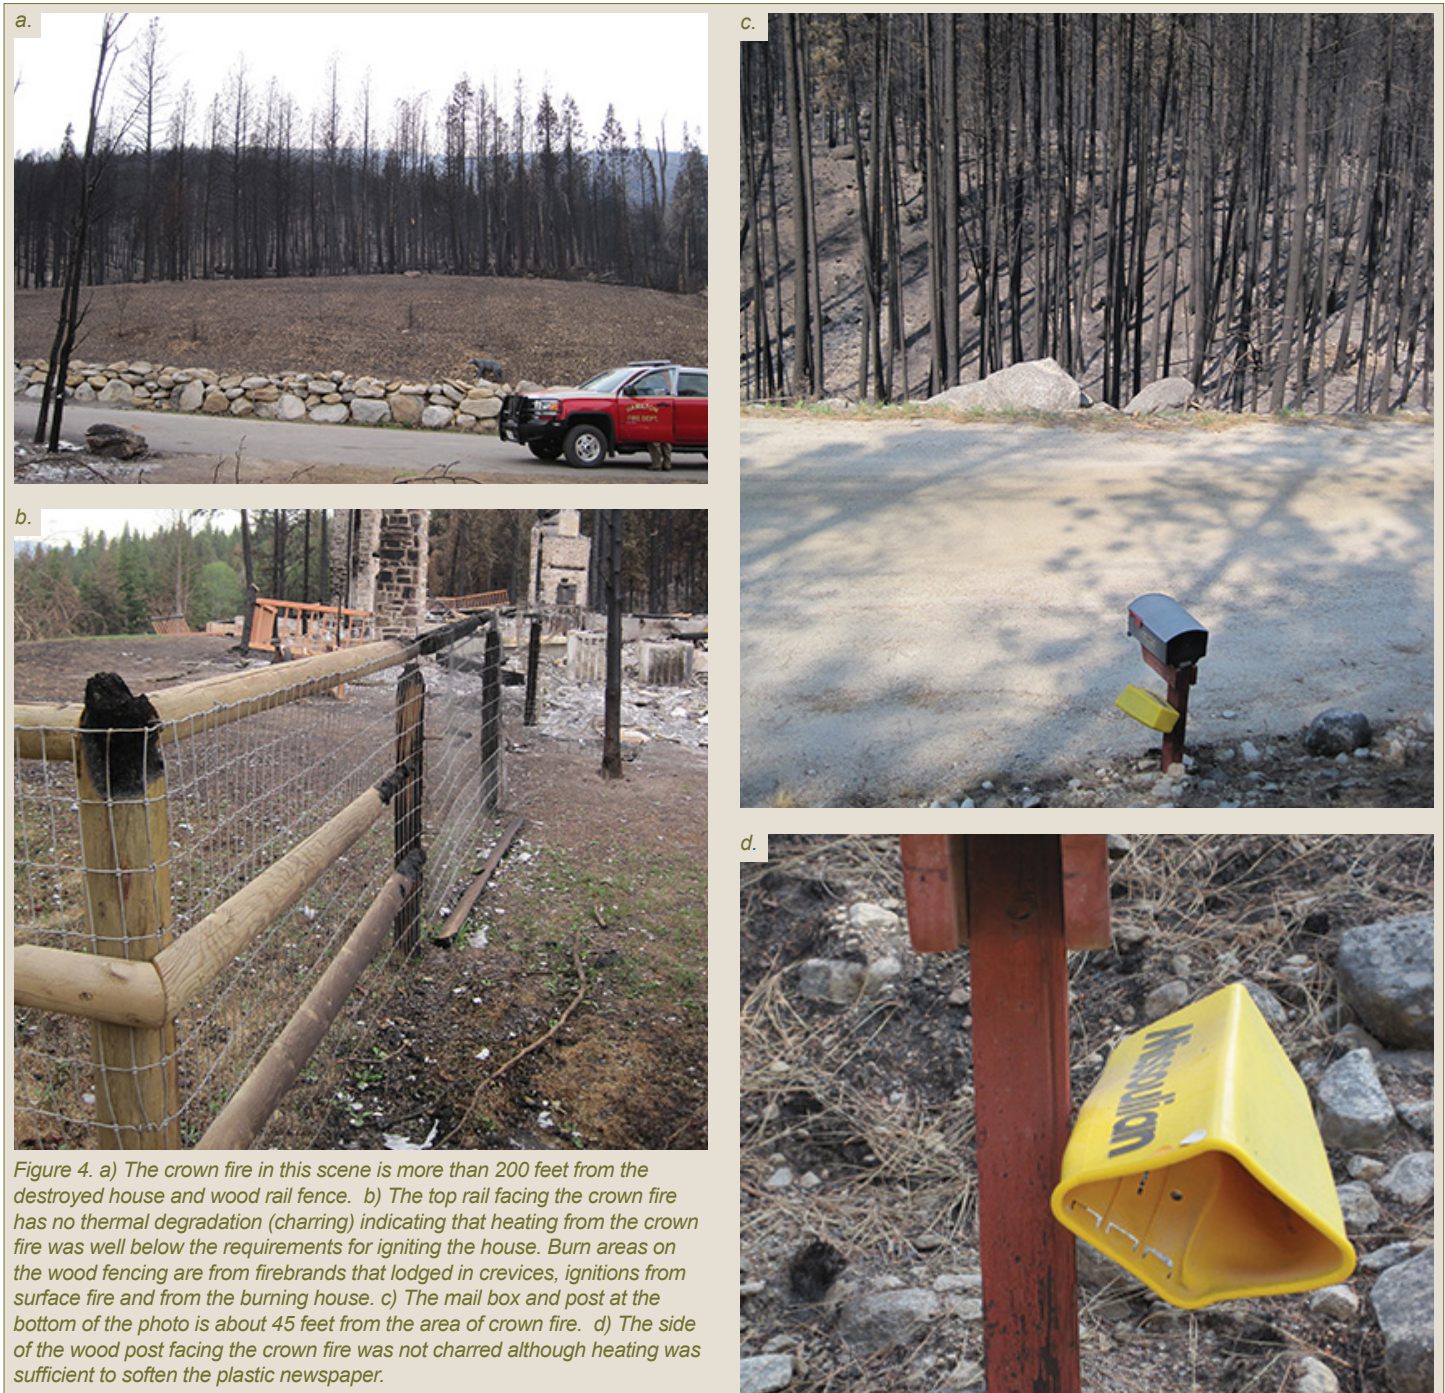
Figure 4. a) The crown fire in this scene is more than 200 feet from the destroyed house and wood rail fence. b) The top rail facing the crown fire has no thermal degradation (charring) indicating that heating from the crown fire was well below the requirements for igniting the house. Burn areas on the wood fencing are from firebrands that lodged in crevices, ignitions from surface fire and from the burning house. c) The mail box and post at the bottom of the photo is about 45 feet from the area of crown fire. d) The side of the wood post facing the crown fire was not charred although heating was sufficient to soften the plastic newspaper.

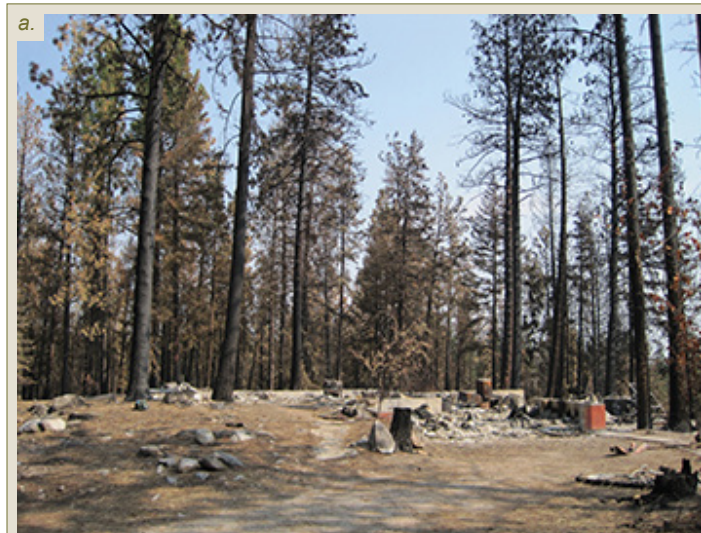
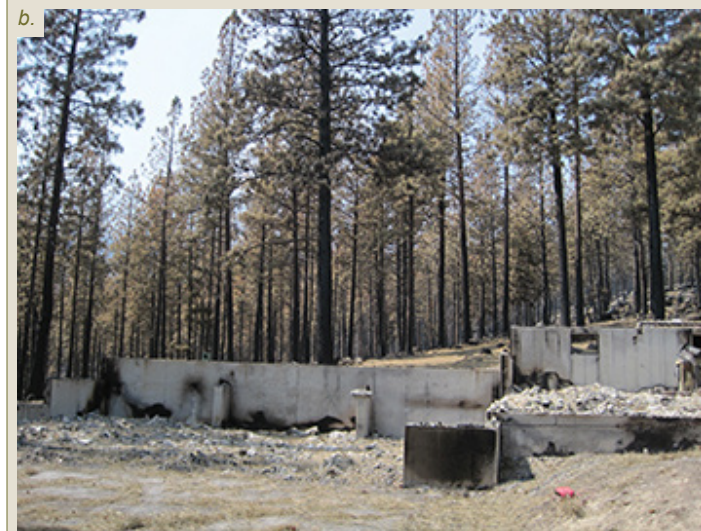
Figure 5. Two different houses a) and b). Neither house had adjacent high intensity burning. The charred and partially consumed trees adjacent to the houses burned from the burning house. The a) house did not have forest fuel treatment; the b) house had forest fuel treatment.

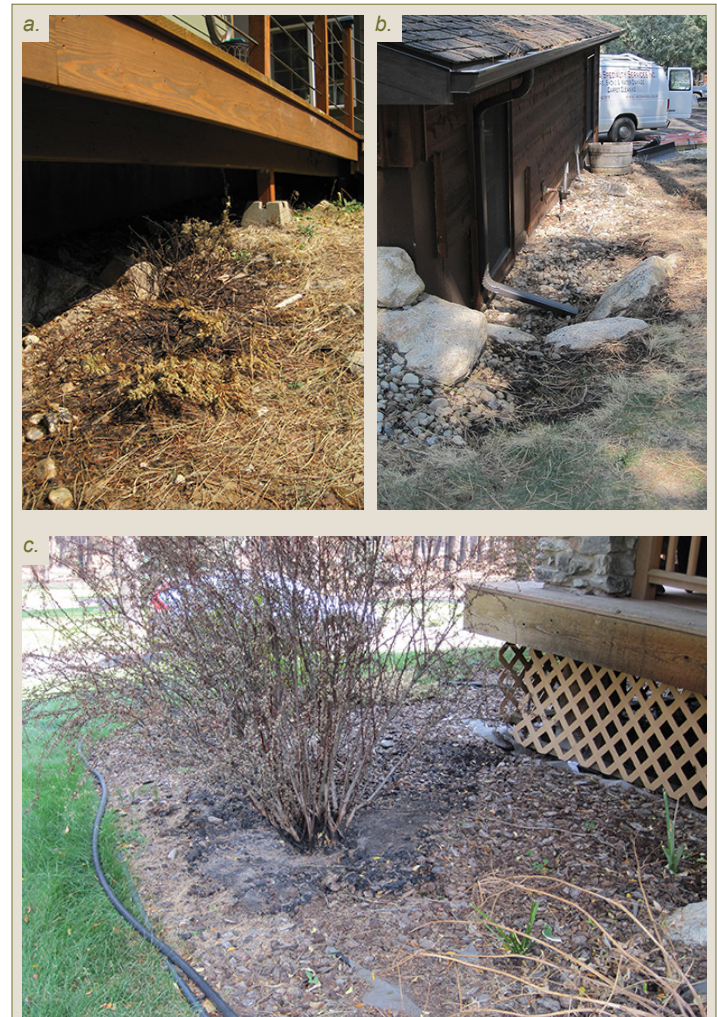
Figure 6. Three examples (a, b and c) of spot-fires ignited by firebrands. Each of these spot-fires demonstrate how important the house and its immediate surroundings are to the home ignition potential. It could not be determined if firefighters extinguished the spot-fires and prevented home ignitions.

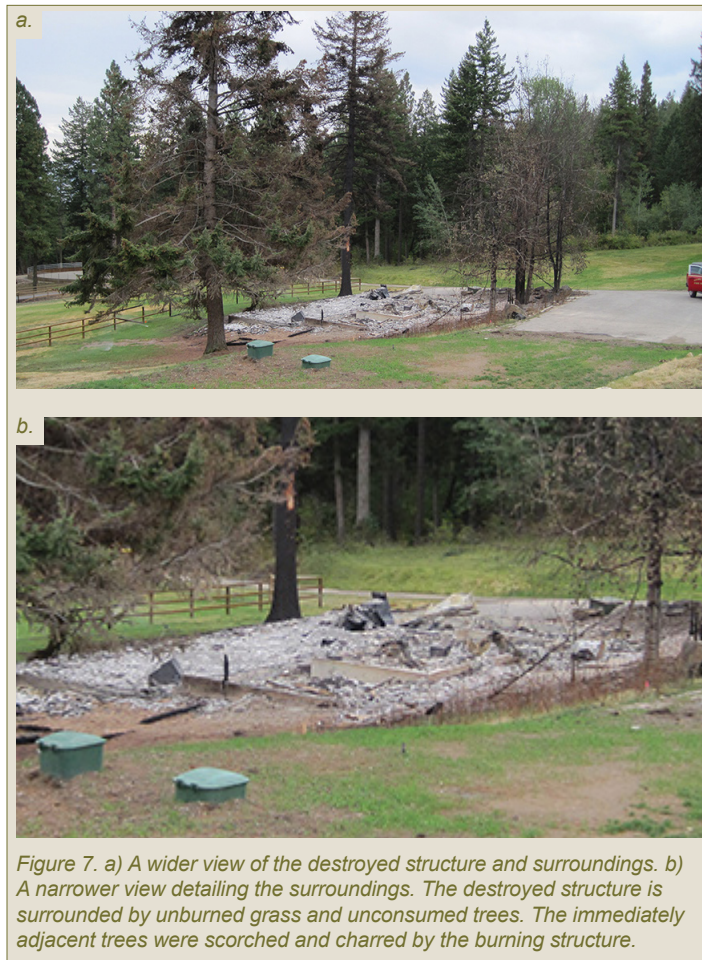
The destroyed structure in Figure 7 was located in an irrigated meadow with fuel treatment in parts of the adjacent forested area. Unconsumed vegetation surrounded the destroyed structure without evidence of fire spreading to the structure; the adjacent scorched and charred trees were due to the burning structure. The total lack of wildfire flame exposure immediately surrounding the destruction indicated a firebrand ignition source. This conclusion was supported by an active crown fire within ¼ mile and up wind of the destroyed structure.

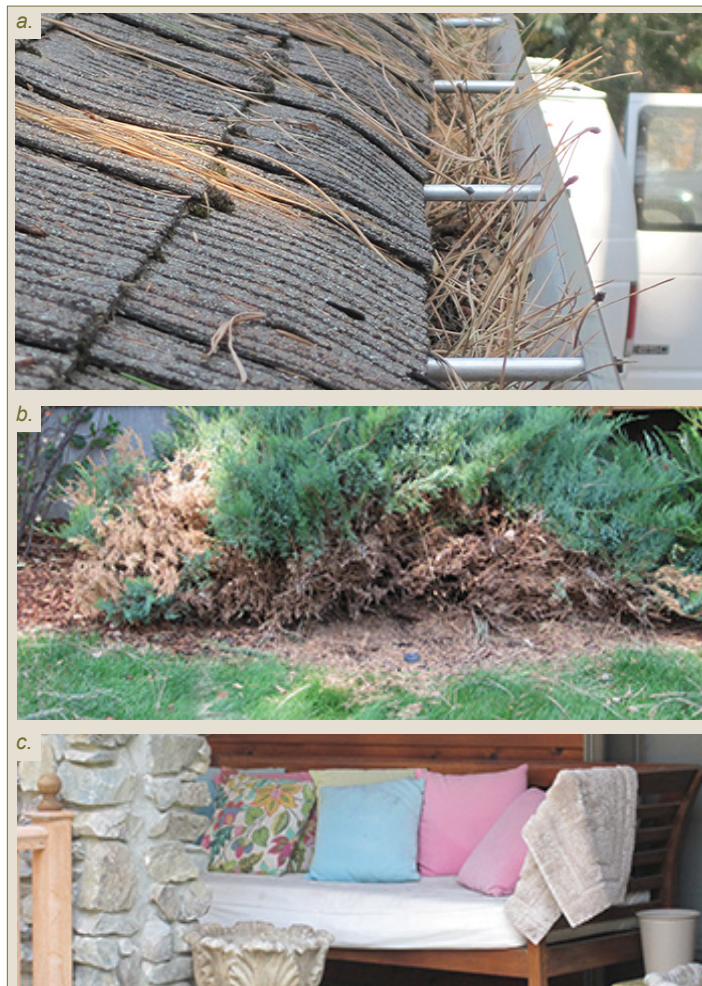
Figure 9. Example firebrand ignition vulnerabilities of houses. a) Burning dead pine needles in the rain gutter can ignite the house at the eave. b) Burning evergreen shrub from ignited dense dead material inside produces structure flame contact on the wall and under the “push-out.” c) Flammable patio furniture cushions and pillows can burn to produce flame contact with the wall and fracture windows that collapse to allow firebrands and flames to penetrate the interior.

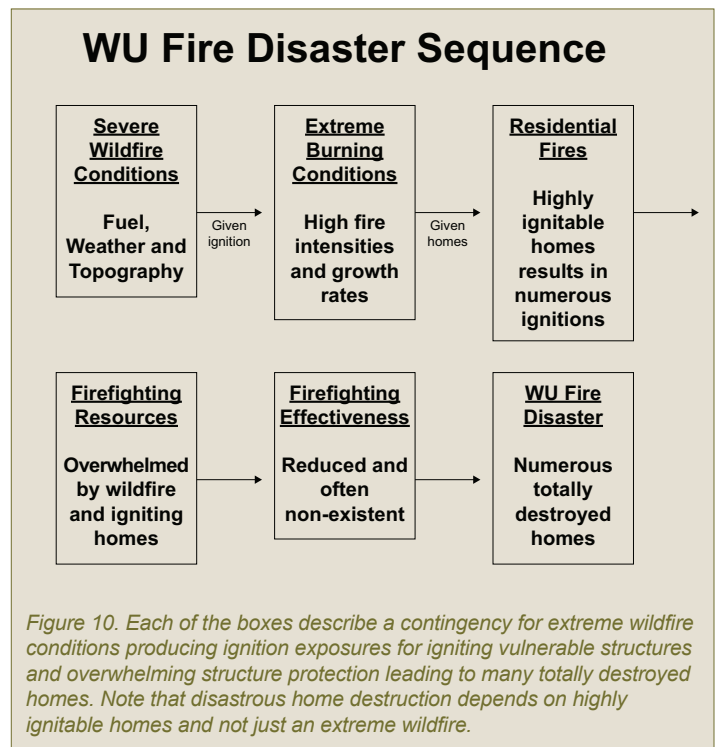
Figure 10. Each of the boxes describe a contingency for extreme wildfire conditions producing ignition exposures for igniting vulnerable structures and overwhelming structure protection leading to many totally destroyed homes. Note that disastrous home destruction depends on highly ignitable homes and not just an extreme wildfire.
